**Katrice Grace King**

Analysis of the water resources in the rural village of Andavadoaka, S.W. Madagascar, with the objective of designing a sanitation programme using biogas technology

King, K. G. (2007) Analysis of the water resources in the rural village of Andavadoaka, S.W Madagascar, with the objective of designing a sanitation programme using biogas technology. Blue Ventures Conservation Report.

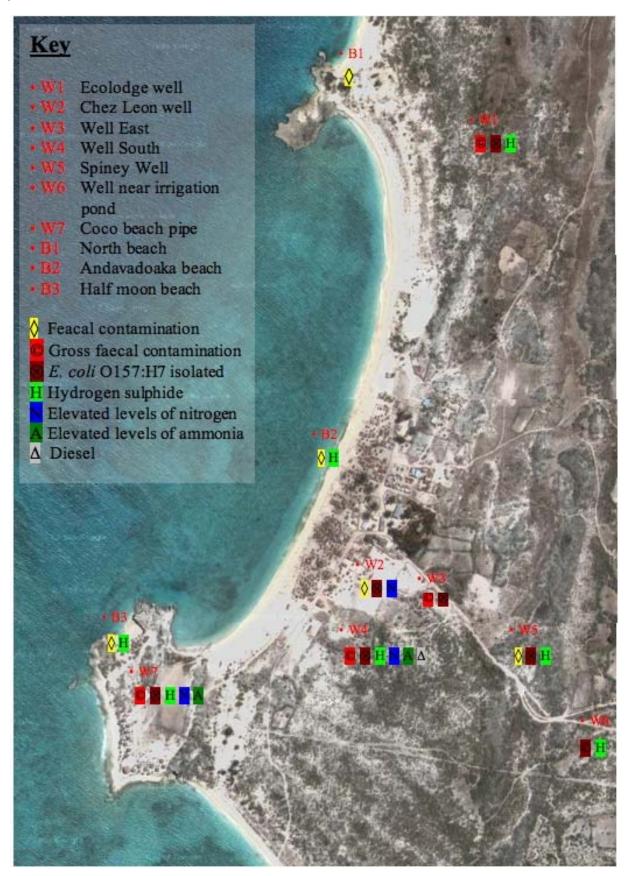
Figure 11. Satellite image of Andavadoaka village with the Microbial and chemical results plotted for each sample site.

The data suggested that all 5 sites sampled showed positive readings for *Enterobacteriaceae* and *E.coli*. Significantly high *Enterobacteriaceae* numbers were seen in Well East and Coco Beach pipe. *E. coli* O157:H7 strain was found in Well East, Well South and Coco Beach pipe. Elevated levels of nitrate and ammonia were found in Coco Beach pipe; the colour of this sample was a dull yellow and contained white aggregate. Well South had a high salinity reading for drinking water, and Well East showed a salinity level that matches seawater levels.

The results from bacterial testing of the 2<sup>nd</sup> (March 2007) and 3<sup>rd</sup> (April 2007) samples are shown in Figures 8 and 9. Gross levels of Enterobacteriaceae colonies were seen in: Ecolodge well, Well East, Well South, Chez Leon well, Well near irrigation pond and North beach. E. coli O157:H7 strain was found in all 6 wells in and around the village. Water in the wells showed a higher pH than the sea water, meaning well water was more alkaline. The salinity level was again high in Well South. Elevated levels of ammonium were seen in Well South and Half Moon Beach, with the Ecolodge well, Well near irrigation pond and Andavadoaka beach emitting a 'rotten egg' smell. Coco Beach pipe water was again discoloured. In addition, during the 3<sup>rd</sup> set of testing, Well South had a distinctive smell of diesel. Figure 11 shows the extent of contamination.
